Inspection Report

Sample Report

Property Address:
12345 Wonderland Ave.
Alicetown CA 12345

First Safety Home Inspection L.L.C.

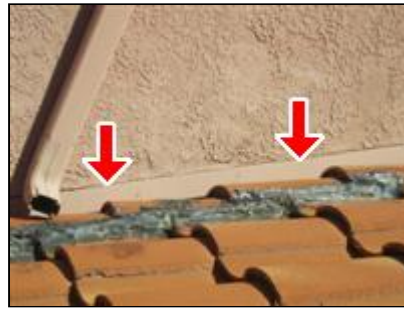
1.0 Item 1(Picture)

1.0 (2) Some of the roof tiles were sealed(patch) with silicone. This may indicate prior leakage. Further evaluation by a roofing contractor is advised.

(2) Some of the roof tiles were sealed(patch) with silicone. This may indicate prior leakage. Further evaluation by a roofing contractor is advised.

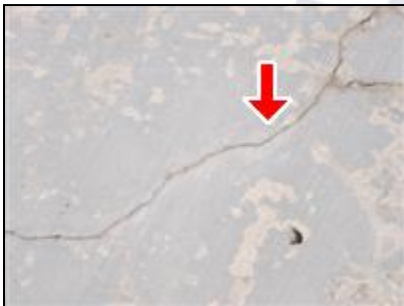
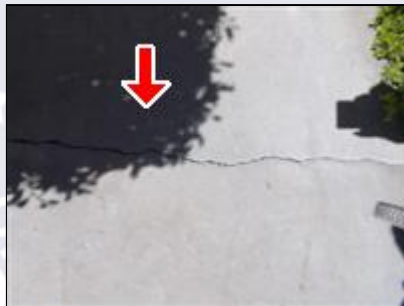
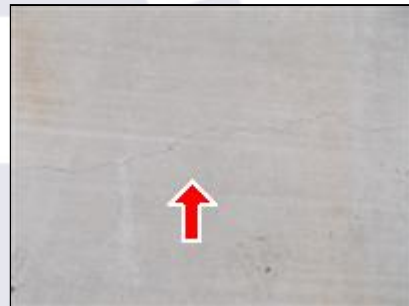
2.5 Item 1(Picture)

2.5 (1) Stress cracks were observed in the concrete driveway, walkways and front slab.

NOTE: Stress cracks in masonry, brick, block, stone or concrete can be filled with hydraulic cement.

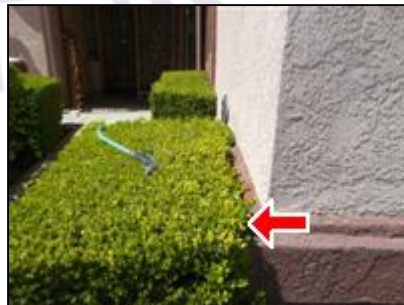
2.5 Item 4(Picture)

2.5 (2) All shrubbery should be trimmed away from the house at least 4"-6" for proper ventilation.

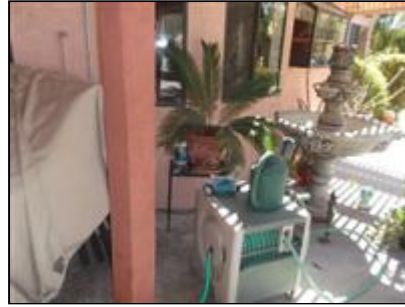
2.5 Item 5(Picture)

2.5 (3) Stored items and personal belonging observed at the rear patio slab. Limited view and access.

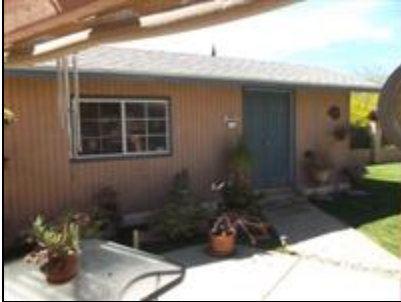
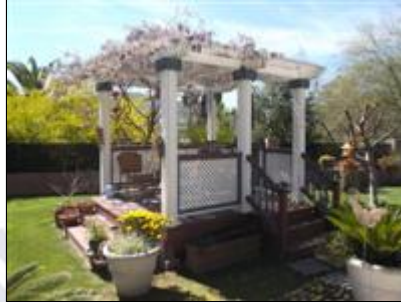
2.6 Item 1(Picture)

2.6 No evaluation on the rear out-building and gazebo. Did not inspect.

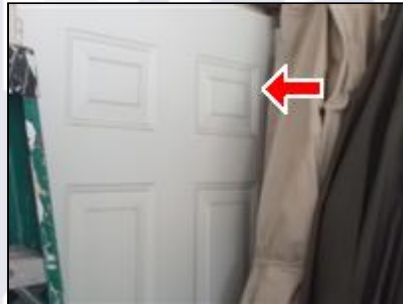
3.1 Item 1(Picture)

3.1 The rear exterior passage door was not accessible due to stored items. No evaluation on operation

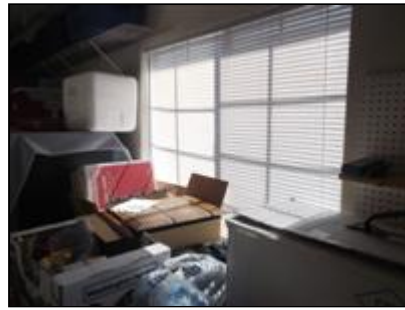
3.6 Item 1(Picture)

3.6 Limited view and access due to stored items.

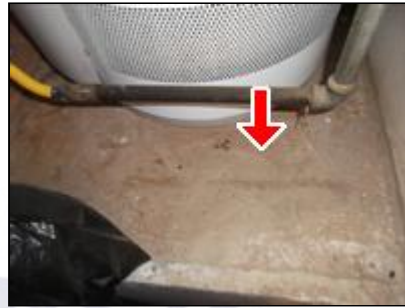
3.7 Item 1(Picture)

3.7 (1) The platform for the water heater is part of the firewall protection. It is missing its fire-proof wallboard at the top of the platform. Repair is advised for safety.

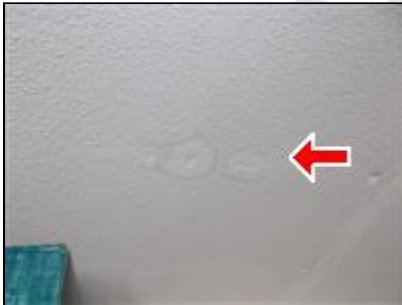
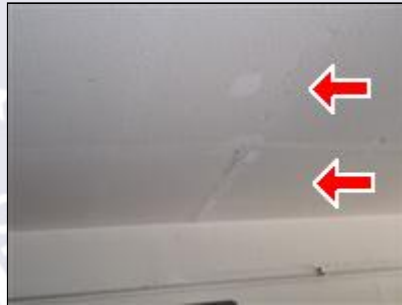
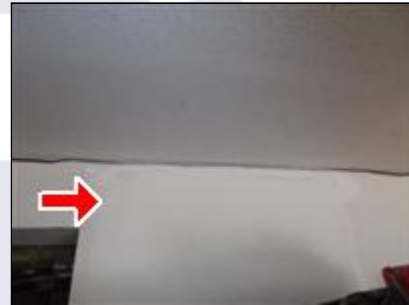
3.7 Item 2(Picture)

3.7 (2) Water stains were observed on the firewall ceiling and a patched area was observed on the firewall. Further evaluation is advised.

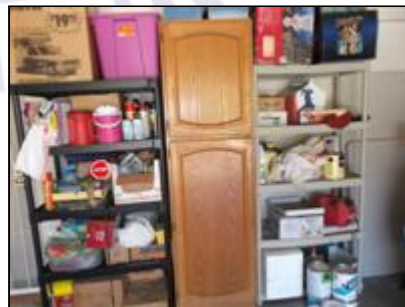
3.7 Item 5(Picture)

3.7 (3) Limited view and access to the firewall due to stored items and personal belonging.

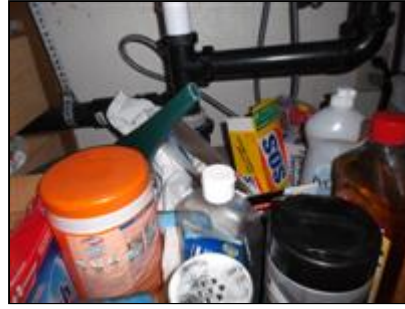
5.3 Item 1(Picture)

5.3 Limited view and access under the sinks due to stored items and personal belongings.

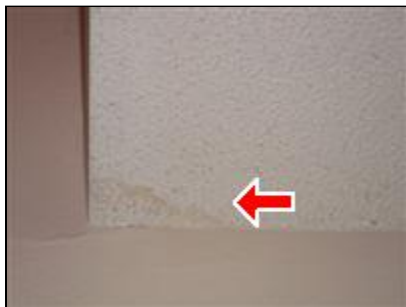
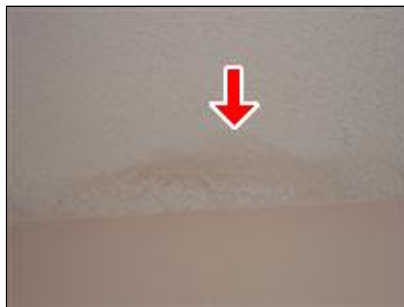
7.0 Item 1(Picture)

7.0 Evidence of prior water leakage at the 1st floor front dining room ceiling. Further evaluation is advised to ensure that the leaks have been repaired.

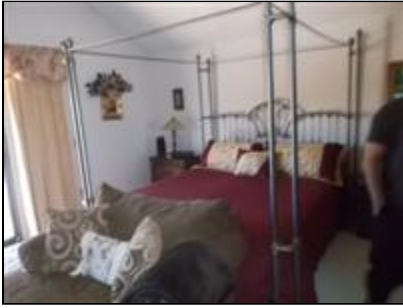
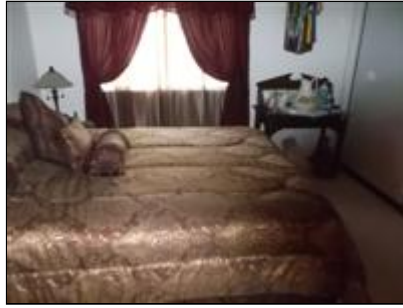
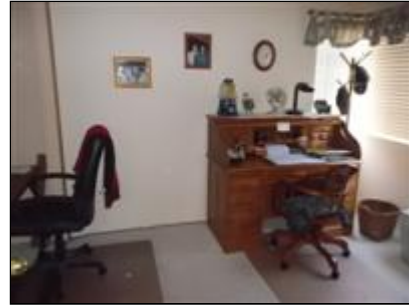
7.1 Item 1(Picture)

7.1 Limited view due to stored items and personal belongings.

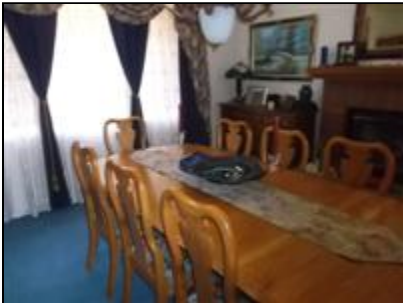
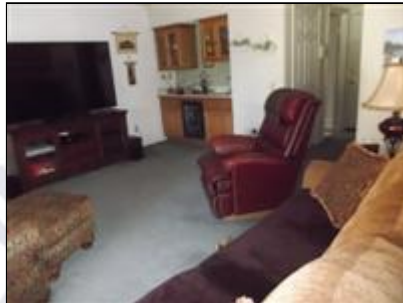
7.2 Item 1(Picture)

7.2 Limited view and access to the interior due to stored items and personal belonging.

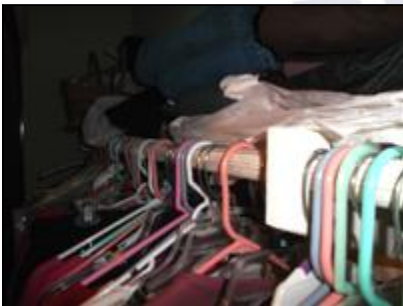
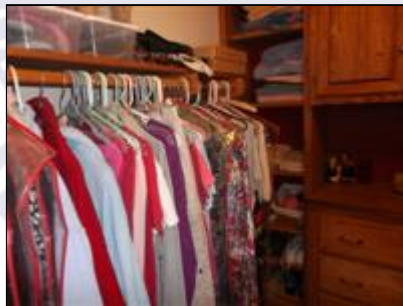
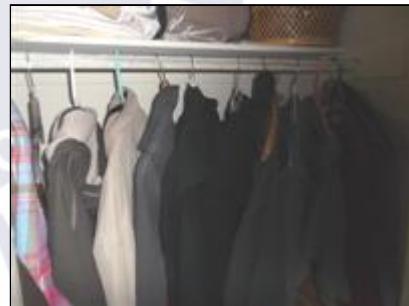
7.4 Item 1(Picture)

7.4 (1) Limited view due to stored items and personal belongings.

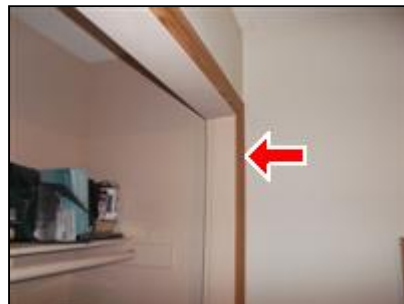
7.4 Item 4(Picture)

7.4 (2) The closet doors were missing at the 2nd floor front/right bedroom. Replacement is advised.

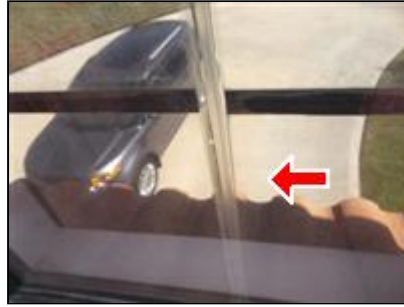
7.5 Item 1(Picture)

7.5 The metal grid was missing at the window in the 2nd floor front/left bedroom.

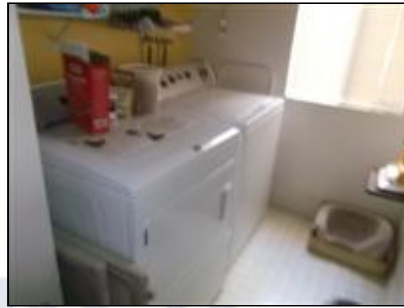
7.7 Item 1(Picture)

7.7 Limited view and access to the laundry area due to stored items and personal belongings.

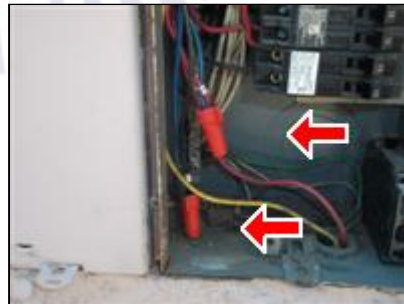
8.2 Item 1(Picture)

8.2 (1) All wire nuts should be taped for safety.

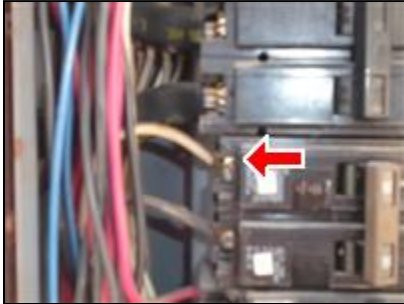
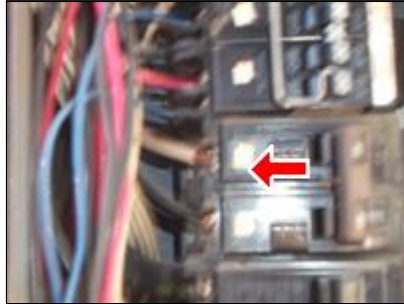
8.2 Item 2(Picture)

8.2 (2) A white wires appears to be used for a conductor wire on the 40 and 30 amp 220 V breakers. The wire should be indicated as a conductor wire by installing black or red tape around the wire for safety.

8.2 (3) NOTE: All electrical work should be performed by a Lic. electrician for safety.

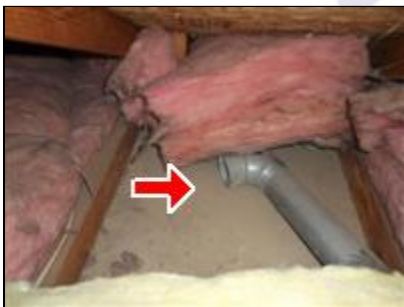
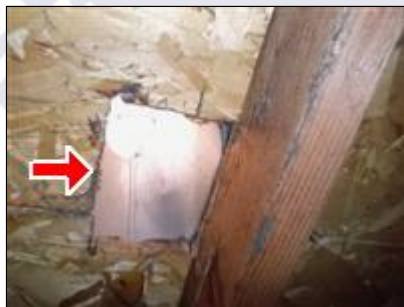
8.7 Item 1(Picture)

8.7 The exhaust pipe was disconnected in the attic for the 2nd floor hall bathroom exhaust fan. Repair is advised.

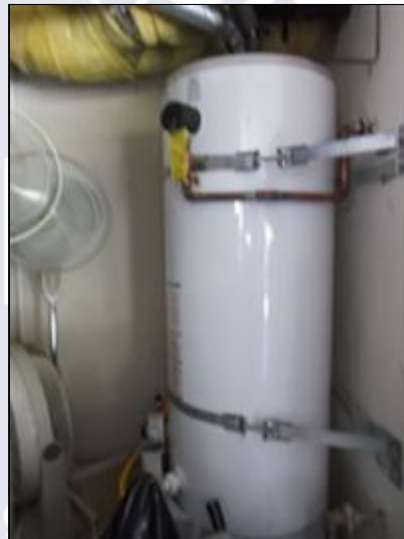
10.2 Item 1(Picture)

10.2 (1) The water heater is located in the garage.

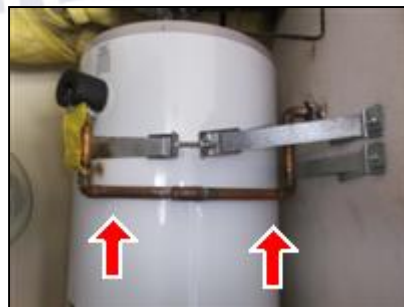
10.2 Item 2(Picture)

10.2 (2) Existing piping for T&P valve on water heater is piped going up instead of going down. This is a safety issue and should be repaired. Recommend a qualified licensed plumber repair or correct as needed.

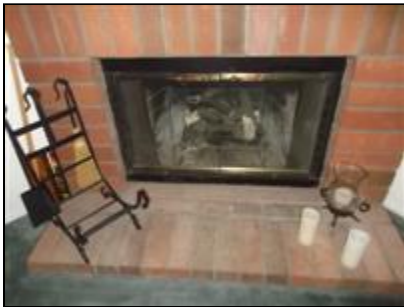
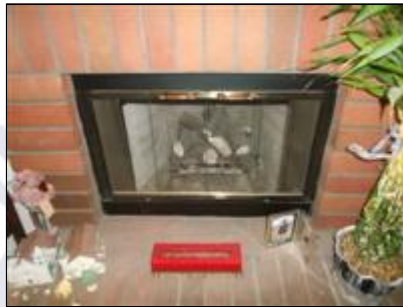
11.4 Item 1(Picture)

11.4 The fireplaces were not operated at time of inspection. A qualified chimney sweep should evaluate to insure their proper operation and safety.

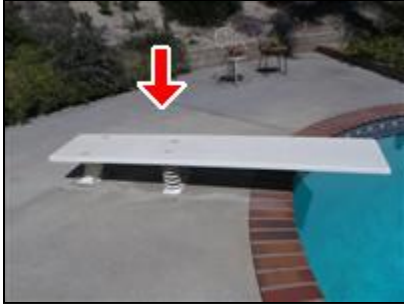
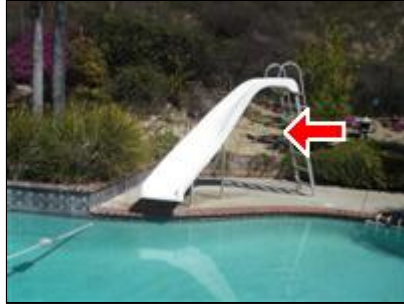
13.2 Item 1(Picture)

13.2 The diving board and slide should be further evaluated to ensure that they are secured properly to the concrete deck/slab.

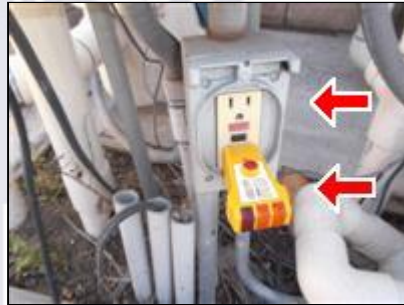
13.7 Item 1(Picture)

13.7 GFCI (Ground Fault Circuit Interrupter) outlet for the pool/spa lighting did not "Trip" when tested and the weather-proof cover was damaged. This is a safety issue that needs to be corrected. Recommend a qualified licensed electrician perform repairs that involve wiring.
